## METALLURGICAL EXAMINATION AND MECHANICAL TESTS OF MATERIAL FROM THE POINT PLEASANT, W. VA. BRIDGE

## METALLURGICAL EXAMINATION AND MECHANICAL TESTS OF MATERIAL FROM THE POINT PLEASANT, W. VA. BRIDGE PART I

By  
John A. Bennett  
Engineering Metallurgy Section  
Metallurgy Division

Part I. Examination of Fractures and Adjacent Material  
in C13 Eye of Eyebars C11-C13 NN

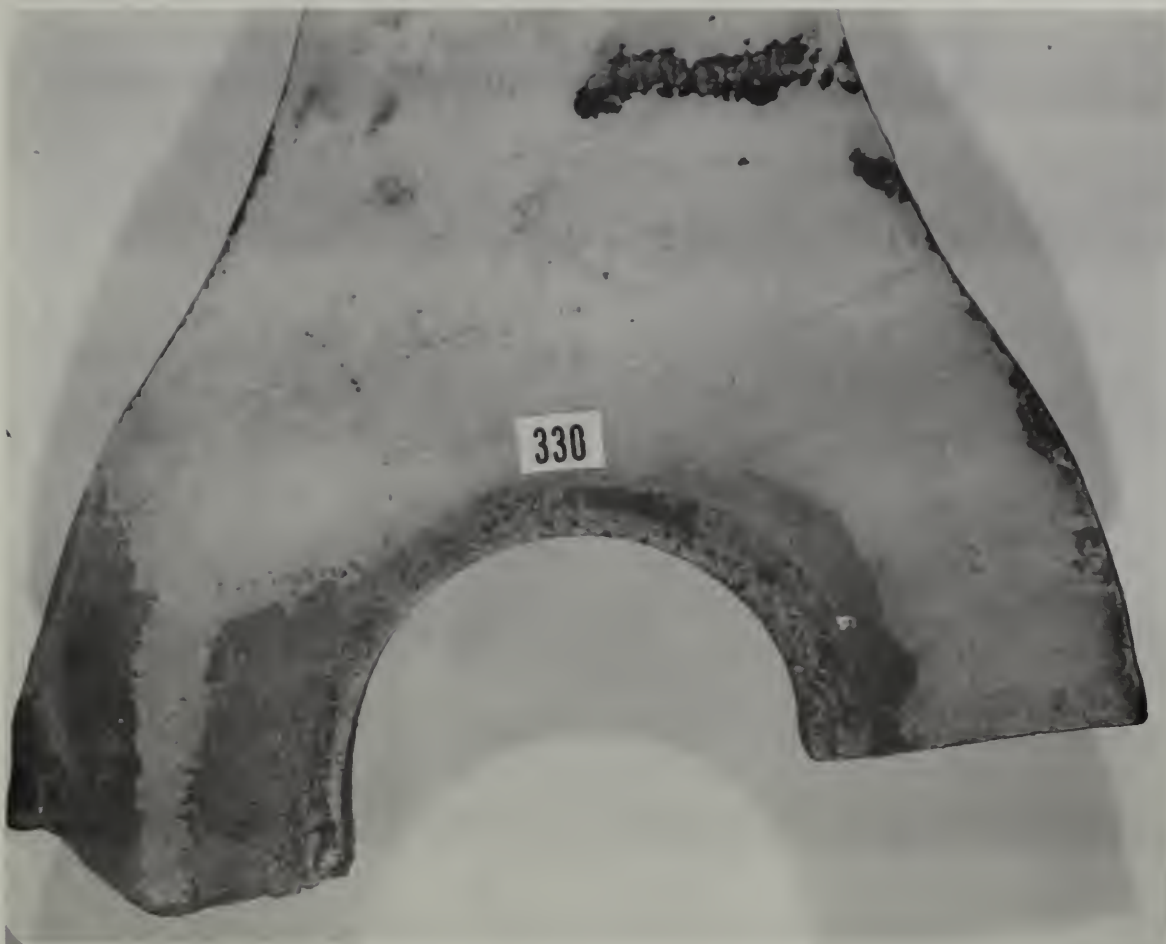
Visual observations: The appearance of the fractured eye when recovered has been described in other reports but will be repeated here for completeness (figs. 1 and 2). The fracture in the lower side of the eye was very brittle in appearance; there was no evidence of plastic deformation adjacent to the fracture except for a small shear lip along a part of one side. Along much of the fracture the paint was intact to within about 1/16 in of the fracture.

1, Inboard piece of the broken eye, as received. The north face is shown, and the lower side of the eye is at the right.

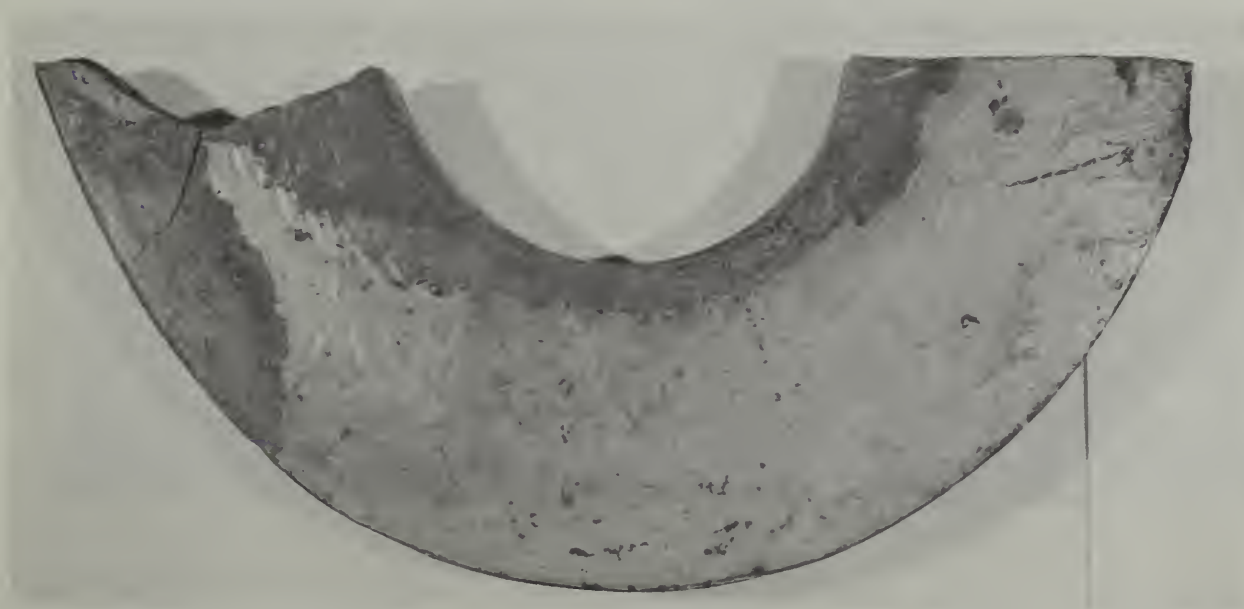
The upper fracture was very different. There was evidence of extensive plastic deformation in the cracking and flaking off of the paint, in the deformation of the hole and in the thinning of the bar, particularly adjacent to the hole. (These dimensional changes can be determined from the measurements made in the Engineering Mechanics Section of NBS and reported earlier by A. F. Kirstein.) The pattern of the paint flaking indicated that the deformation was due to bending of the side of the eye with, initially, tension on the inside and compression on the outside.

2, Outboard piece of the broken eye, as received, oriented as figure 1.

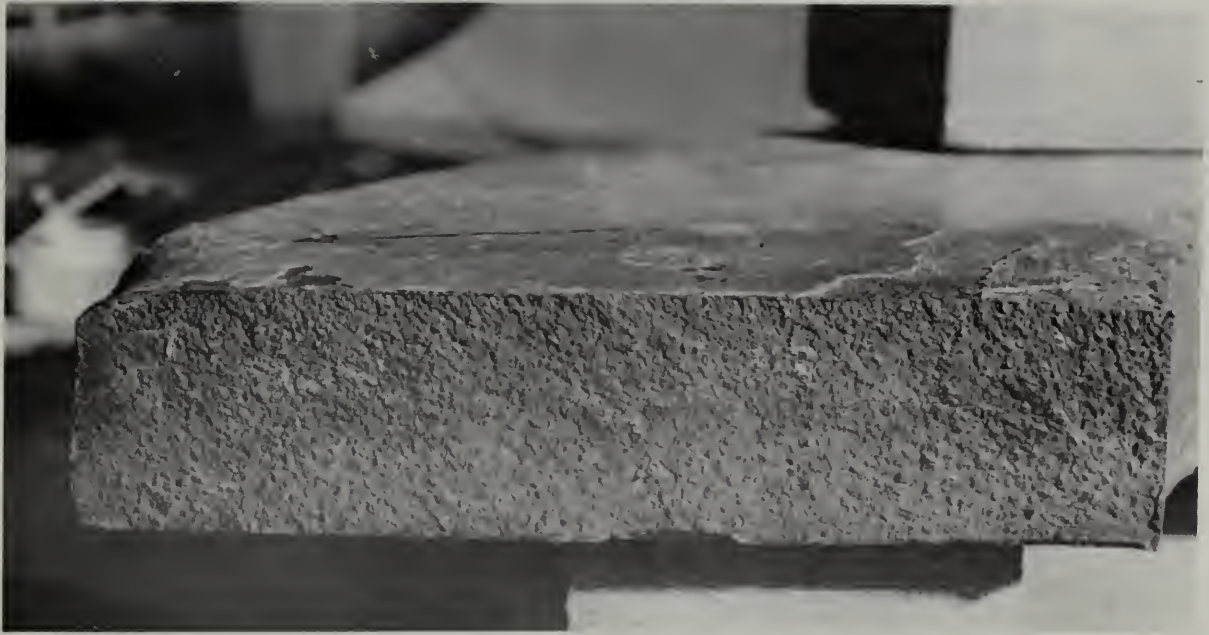
The fracture surfaces also were very different. The lower fracture, figure 3, was almost exactly in a single plane and the roughness was on a fine scale. The upper fracture split into two branches after traversing about two-thirds of the distance from the inside to the outside of the eye, leaving a triangular piece, 5 to 6 inches on a side, nearly broken from the rest of the eye. This fracture surface, figure 4, was much rougher than the lower one, the irregularities being as much as 1/8 inch.

3. Fracture in the lower side of the eye before cleaning. The outboard surface of the fracture is shown, with the north face at the top.

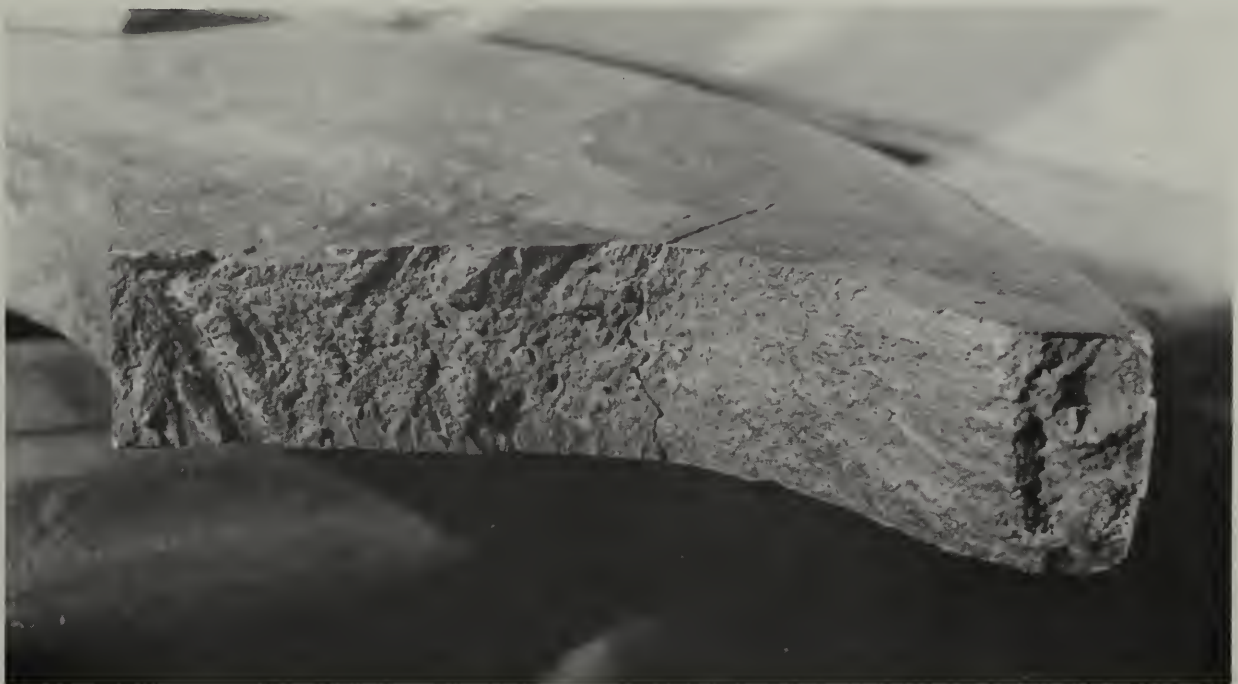
6. The crack on the upper side of the eye occurred after extensive plastic deformation in bending, and the fracture was obviously due to excessive load on the section.

4. Fracture in the upper side of the eye before cleaning. The outboard surface of the fracture is shown, with the north face at the top.

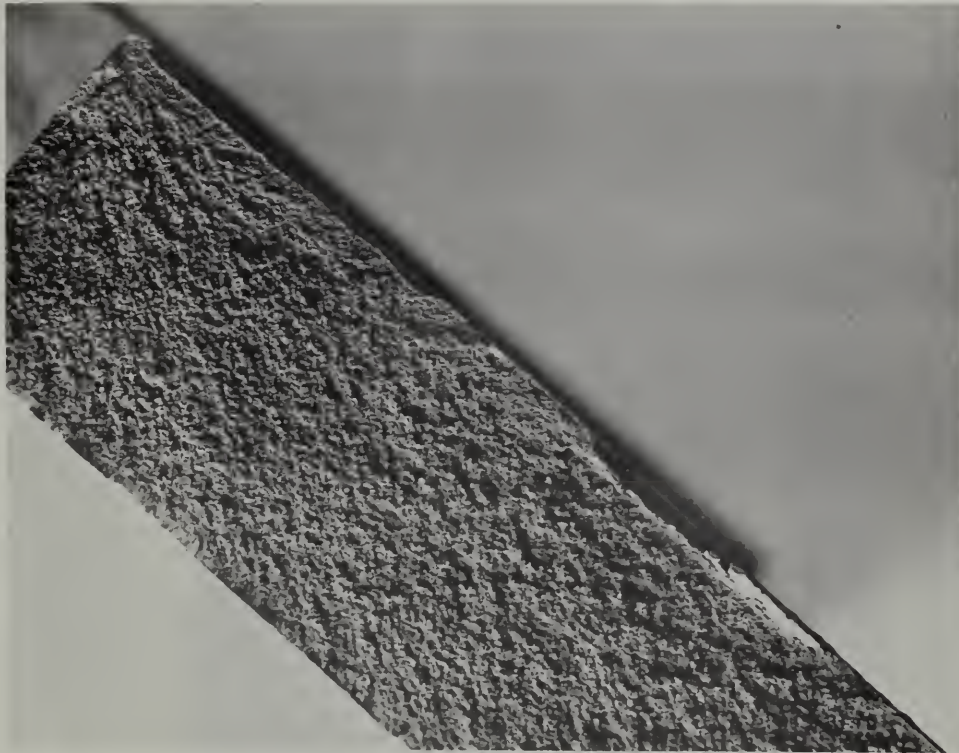
The surface of the lower fracture after cleaning is shown in figures 5 and 6. Figure 5 shows the extent of the shear lip adjacent to the south face of the bar in contrast to the other side, where there was very little lip. In figure 6 the fan-shaped area in the upper corner is the same area referred to earlier which had an adherent dark oxide unlike that on the rest of the fracture. This area is indicated by a solid arrow on figure 6. A similar, but smaller fan-shaped area can be seen just below the one at the corner, (Open arrow). On the inboard side of the fracture the smaller area could be seen clearly, whereas the larger one has been obliterated by battering of the corner after fracture. There appears to be little doubt that these areas represent cracks which existed for some time prior to the final fracture. The larger of these areas extended approximately 0.11 inch in from the surface of the hole.

5. A portion of the outboard fracture surface after cleaning. The south face of the eye is at the upper right, the hole surface at the upper left.

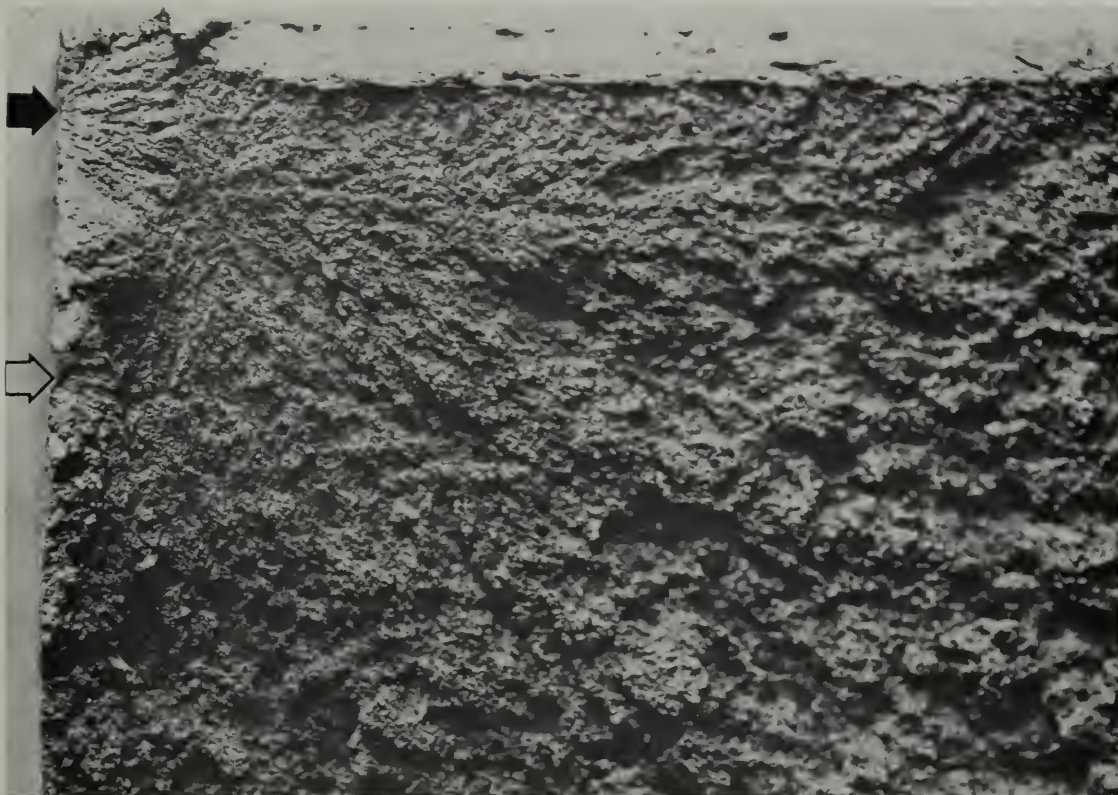
There did not appear to be any marked change in fracture topography associated with the front of the fan-shaped areas visible at the origin on the fracture surface. The larger of these areas (figure 6), had penetrated about 0.11 inch from the hole surface, and the center of it was nearly the same distance from the south face. Figure 16 is a micrograph at low magnification, taken on a plane 0.11 inch from the south face and including the location of the front of the "fan". Although the change in direction of the crack near the middle of this figure may well be associated with the change in appearance of the fracture surface, there are no microscopic differences in the nature of the fracture that we could observe on the two sides of this region.

6. Same as figure 5 at higher magnification. The south face is at the top. 5 X

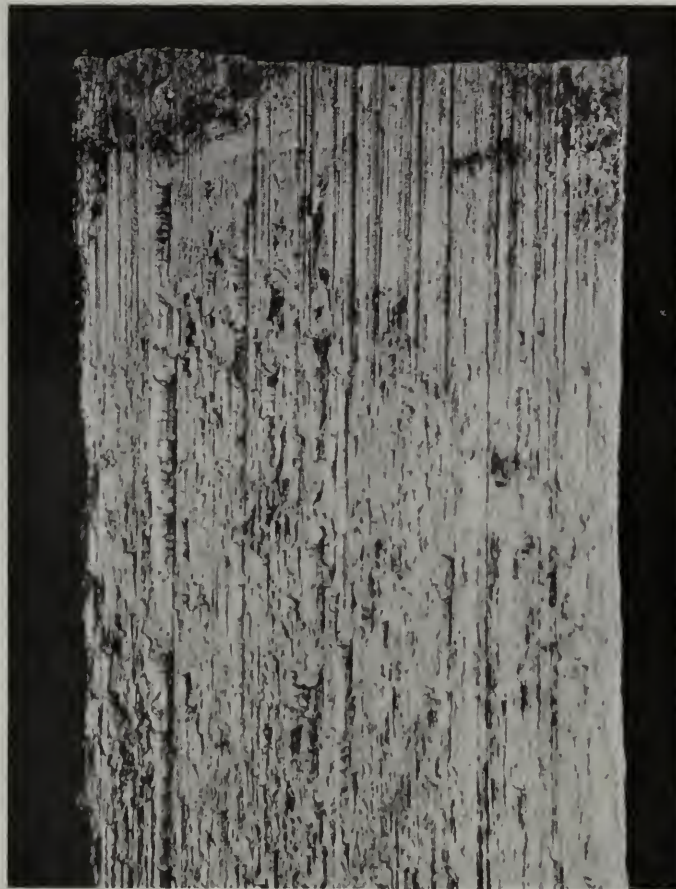
Figure 7 shows the surface of the hole in the outboard piece adjacent to the lower fracture. The poor quality of the machining is evident in this area where the grooves and tears in the surface have not been affected by corrosion because the surface was in tight contact with the pin. There was one area of fairly severe corrosion outboard of the lower fracture; this can be seen at the upper left of the photograph, i.e. adjacent to the south face of the bar. When the corrosion products were cleaned off this area, two cracks were easily visible, figure 8.

7. Surface of the hole adjacent to the fracture (top) in the outboard piece. The south face is at the left.

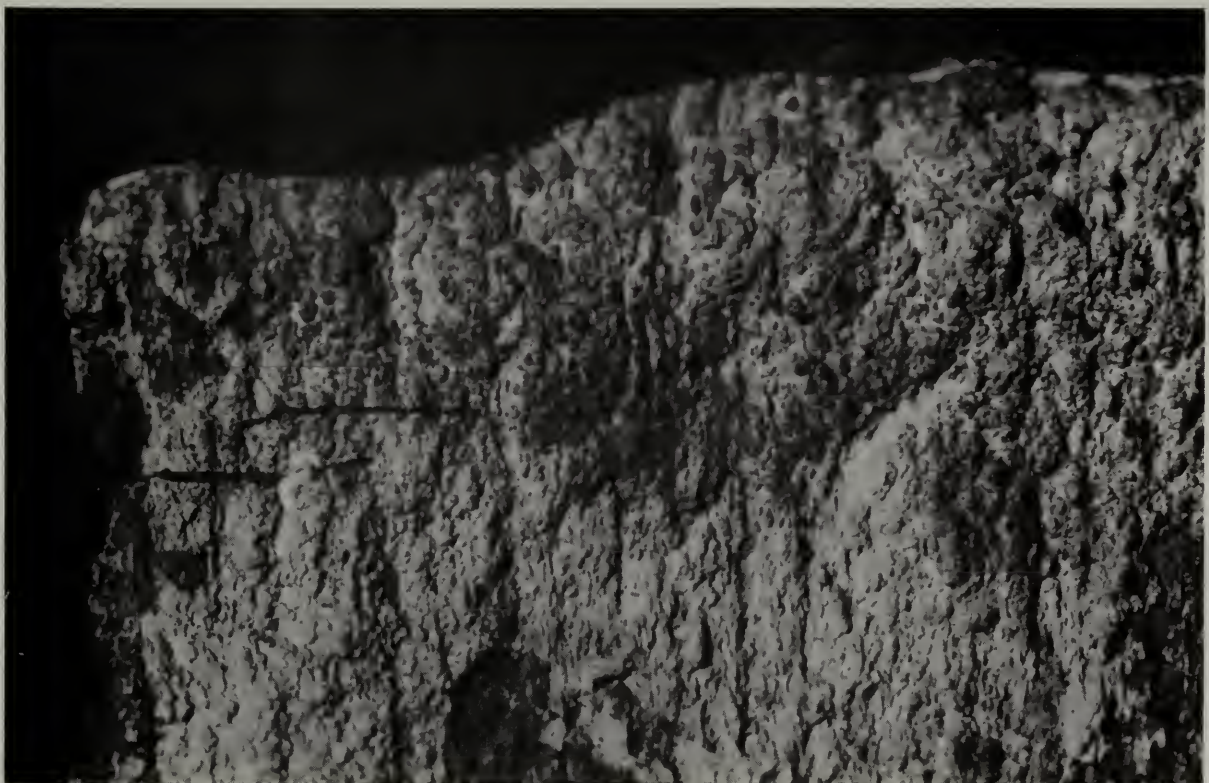
8. Same as figure 7 at higher magnification. 12 X

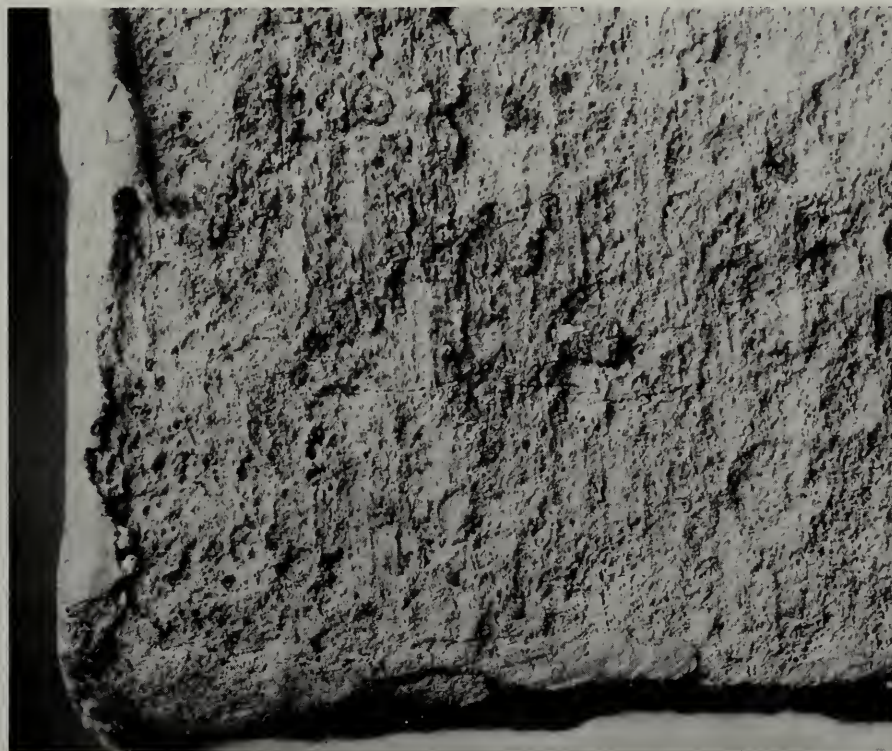
In accordance with the Laboratory Specimen Plan, a segment (designated "0" in the Plan) approximately 1/2 inch thick was separated from the in-board piece of the eye by a saw cut parallel to the lower fracture, figure 9. A number of additional cracks were found on the hole surface in this segment, one group being close to the saw cut, i.e. nearly 1/2 inch from the fracture, (see figures 10 and 11). An attempt was made to locate the origins of these cracks and those in the outboard piece; all of them appeared to have initiated in a region lying between 0.08 and 0.48 inch from the south face. Figure 12 is a sketch, based on visual observations, of the location of the principal cracks.

10. Surface of the hole adjacent to the fracture (bottom) in the inboard piece. The south face is at the left. 6 X

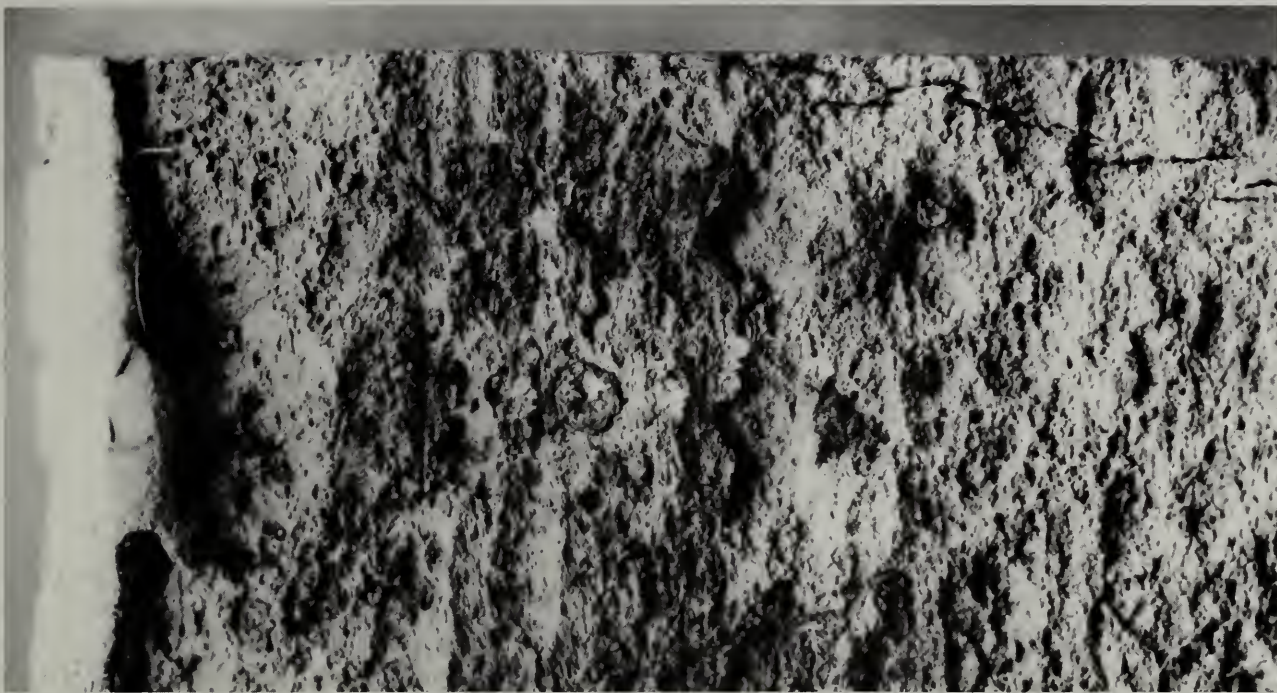
11. Surface of the hole in the inboard piece; the saw cut which separated segment "0" from the eye is at the top, the south face at the left. 12 X

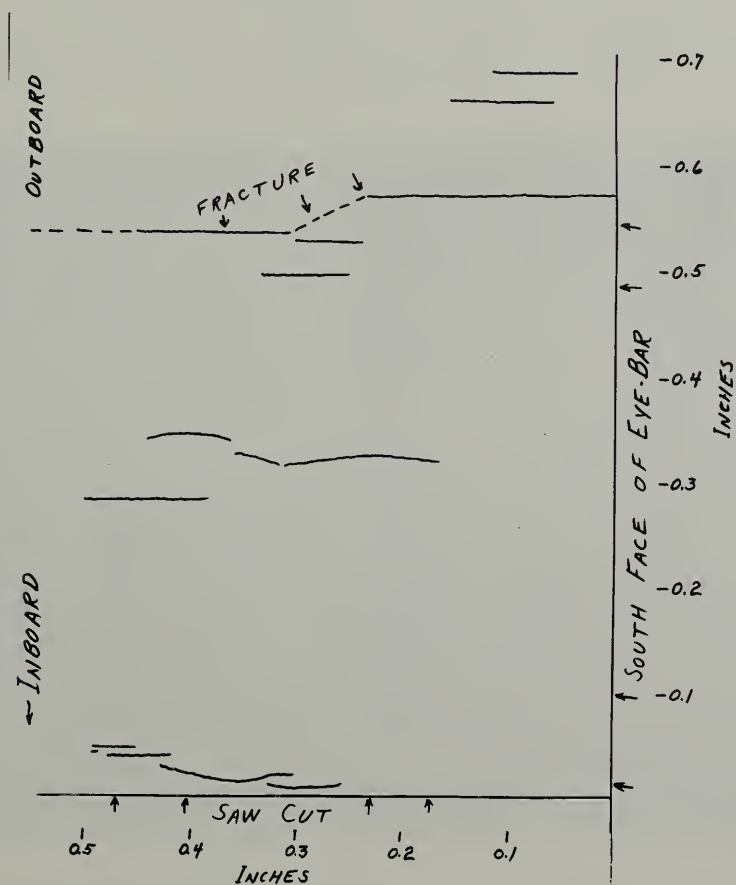
12. Sketch showing the location of cracks visible on the hole surface relative to the fracture and the south face of the eye.

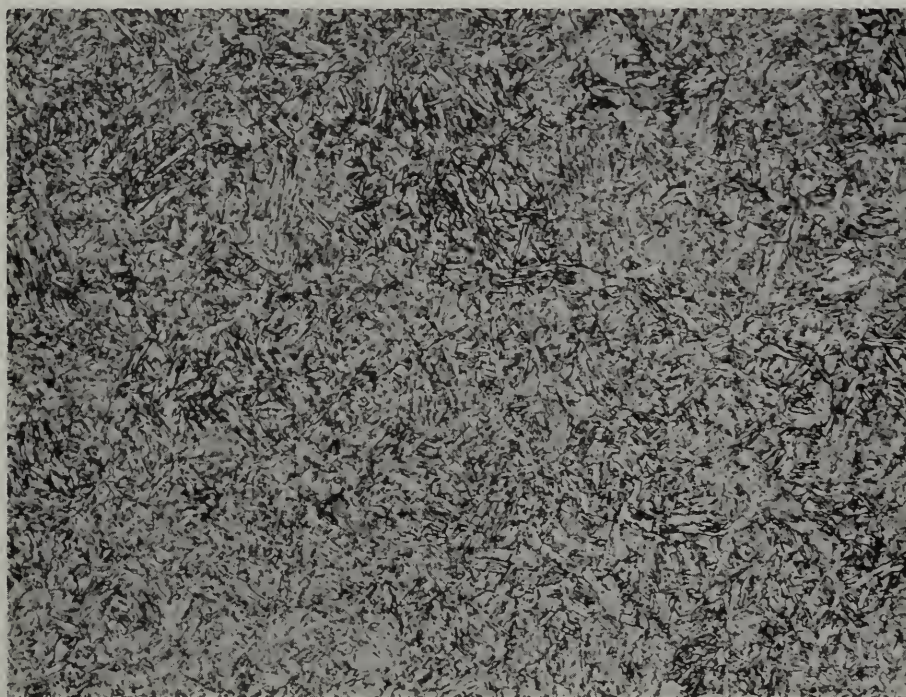
The microstructure of the steel changed with increasing distance from the south face, as can be seen by comparing figures 14, 15, 17, 20, 26 and 27. Near the surface the structure is tempered martensite which becomes mixed slack-quenched products with increasing depth. At greater depths the structure gradually changes to one of pearlite and ferrite. There is some evidence of spheroidization of the carbides, indicating a high tempering temperature.

14. Typical microstructure 0.012 inch below south face. Etched, picral. 200 X

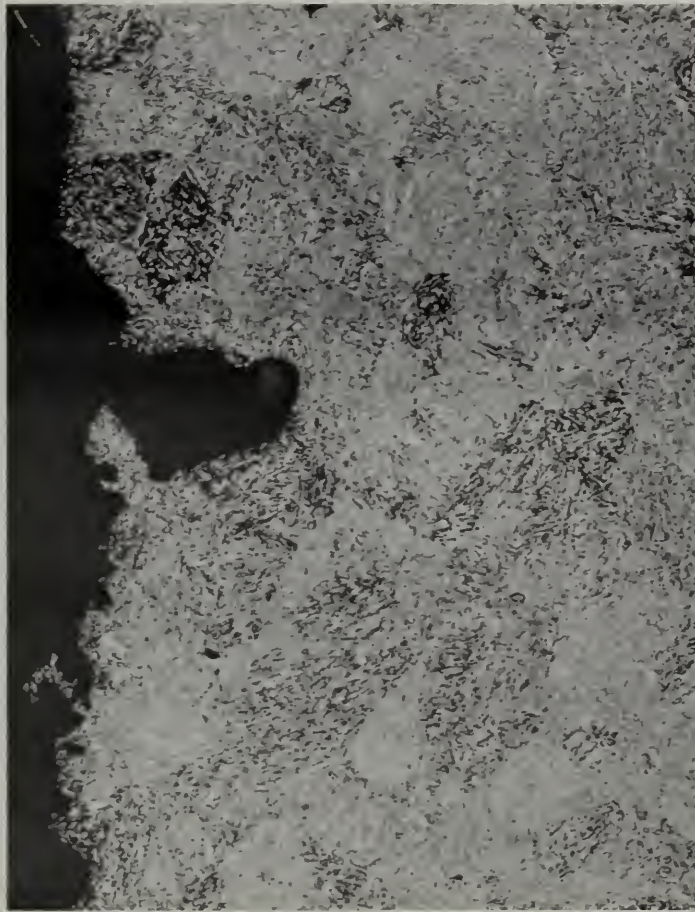
The nature of the cracks that had propagated into the bar from the surface of the hole is shown in figures 18, 19, 20, 22, 23, 24, 25, and 26. They generally appeared to have initiated at corrosion pits, although many severe pits were observed that had no cracks associated with them, as in figure 14. All of the larger cracks were branched, and the branches often appeared to have propagated almost back toward the origin of the crack, figures 18, 22, and 23. Non-metallic material, presumably oxide, was present in nearly all the cracks. A number of cracks changed width abruptly, as in figure 25: also we often observed that the oxide in the wide cracks had a laminated structure which suggested that sudden changes in crack width had taken place, (figure 23).

15. Corrosion on hole surface, 0.039 inch below south face. Etched, picral. 150 X  
 Note: all micrographs are oriented with the fracture at the top and the hole surface at the left.

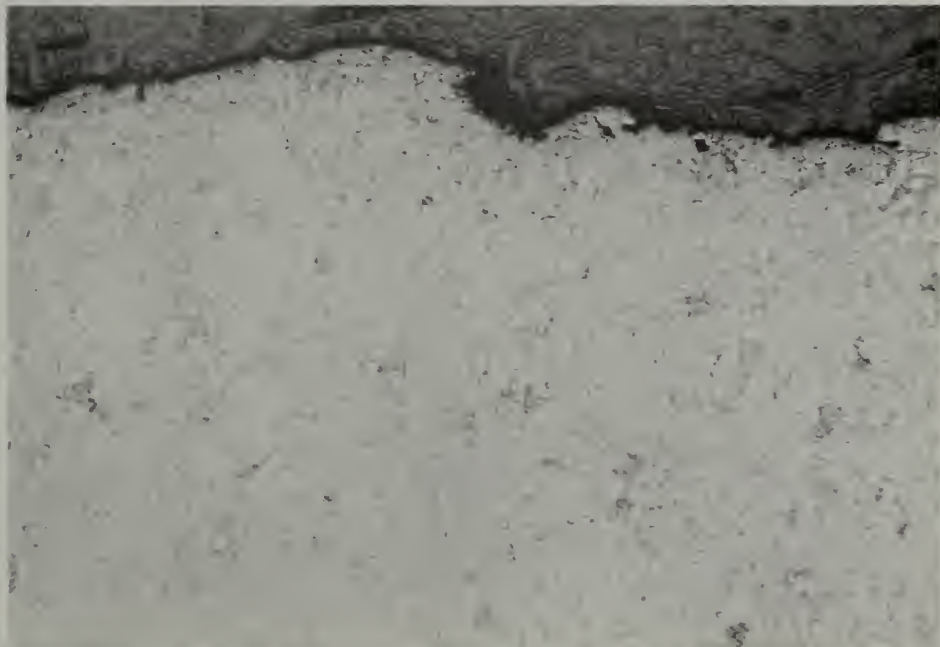
16. Fracture surface on a plane 0.11 inch below south face. Etched, picral. 60 X

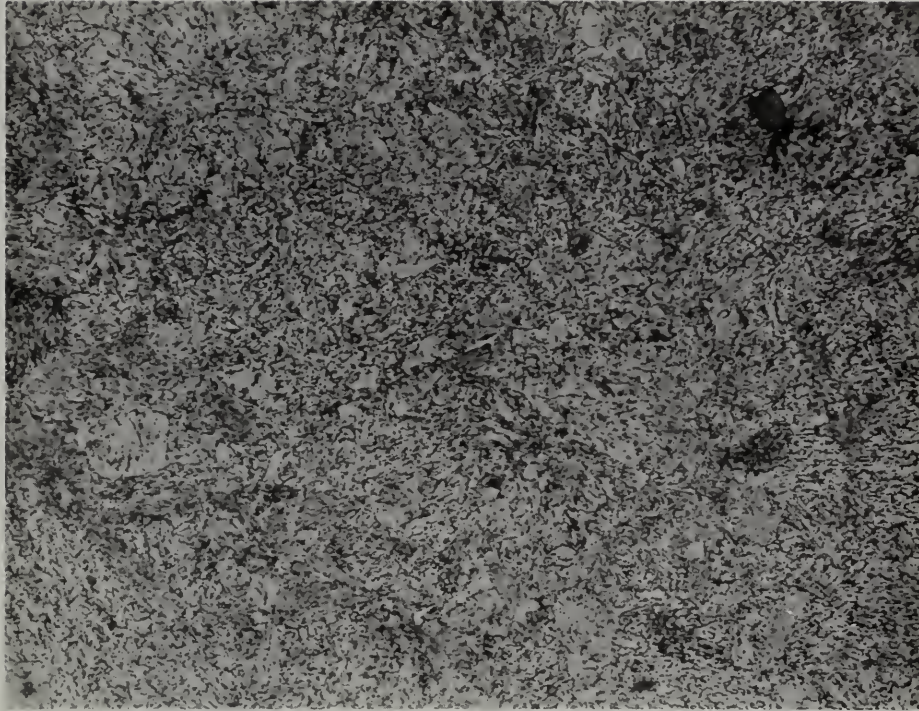
17. Microstructure 0.11 inch below south face, (approximate depth of the origin of the largest crack involved in the fracture). Etched, picral. 500 X

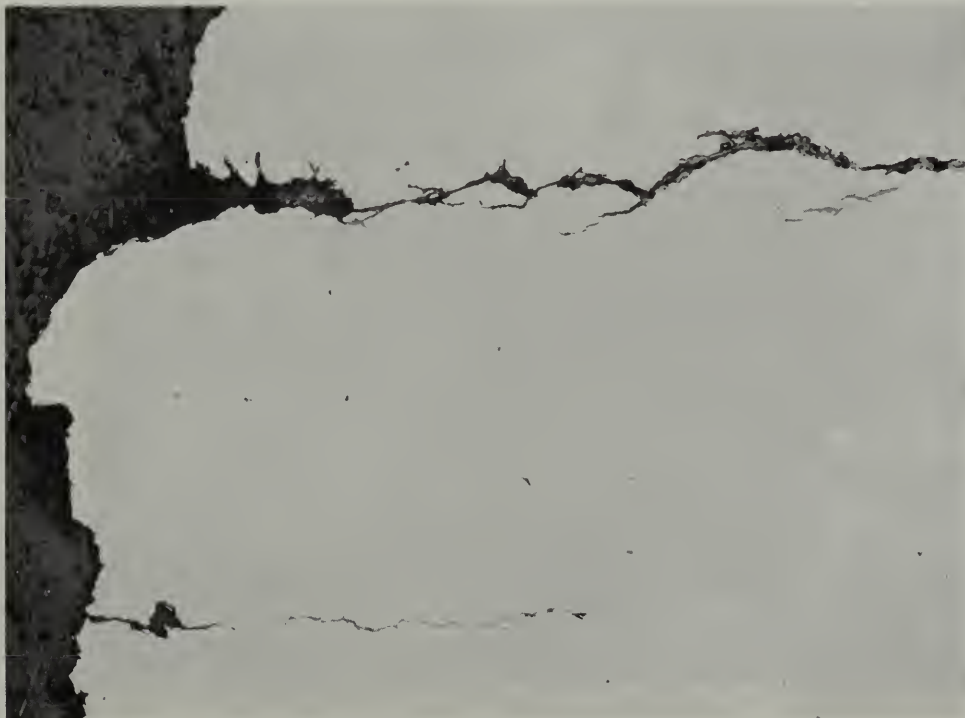
18

Cracks propagating from the hole surface a short distance inboard of the fracture. Depth below south face 0.232 inch. 80 X

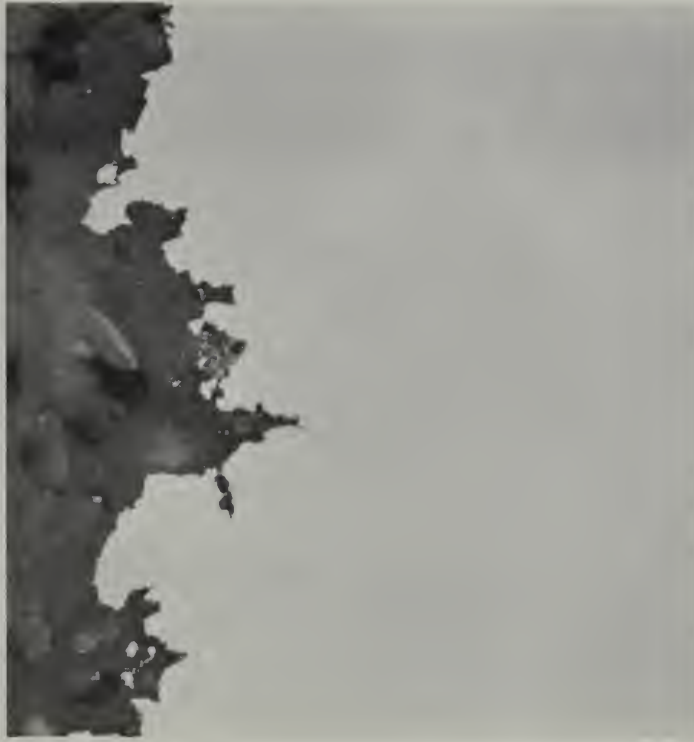
19. Corrosion and incipient cracking on hole surface, 0.285 inch below south face. 500 X

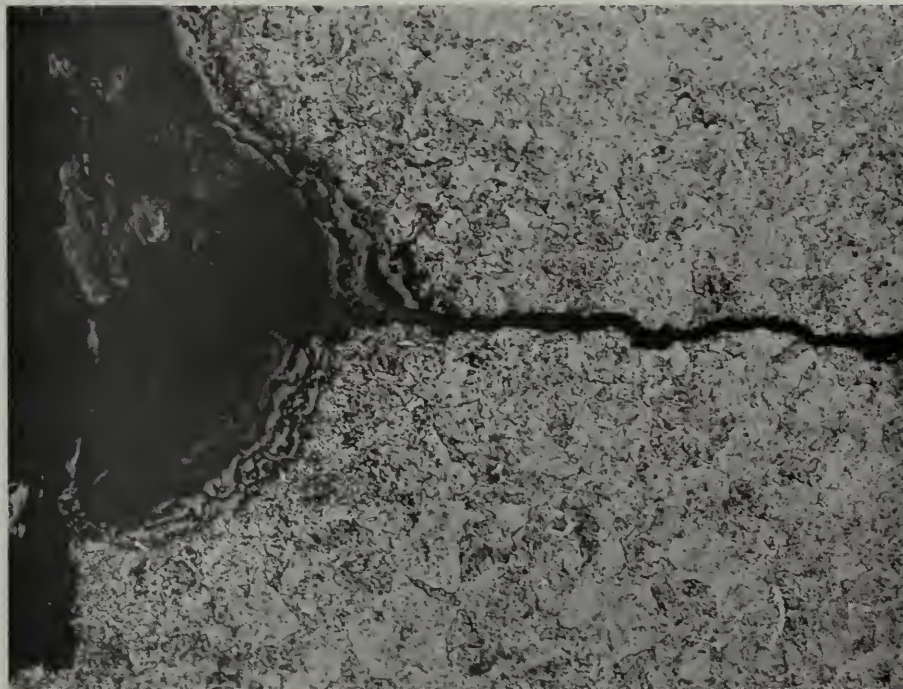
20. Crack origin at a corrosion pit, 0.285 inch below south face. Etched, picral. 200 X

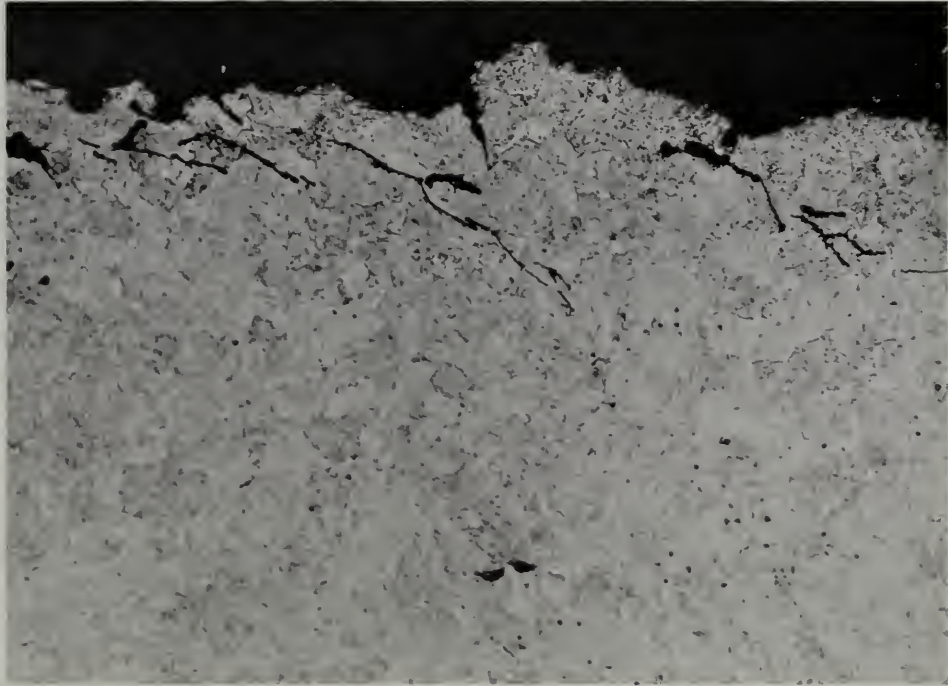
At some distance from the origin there were numerous secondary cracks associated with the fracture, as shown in figures 21 and 27. These were very different from the branch cracks observed near the origin, being generally straighter, narrower, and seldom showing oxidation of the crack faces. An attempt was made to determine how close to the hole there were secondary cracks on some of the sections observed, with the results shown in figure 29. Beyond the dotted line in this sketch, secondary cracking was found on all the metallographic sections examined.

21. Secondary cracks adjacent to the fracture, 0.285 inch below south face. Etched, picral. 200 X

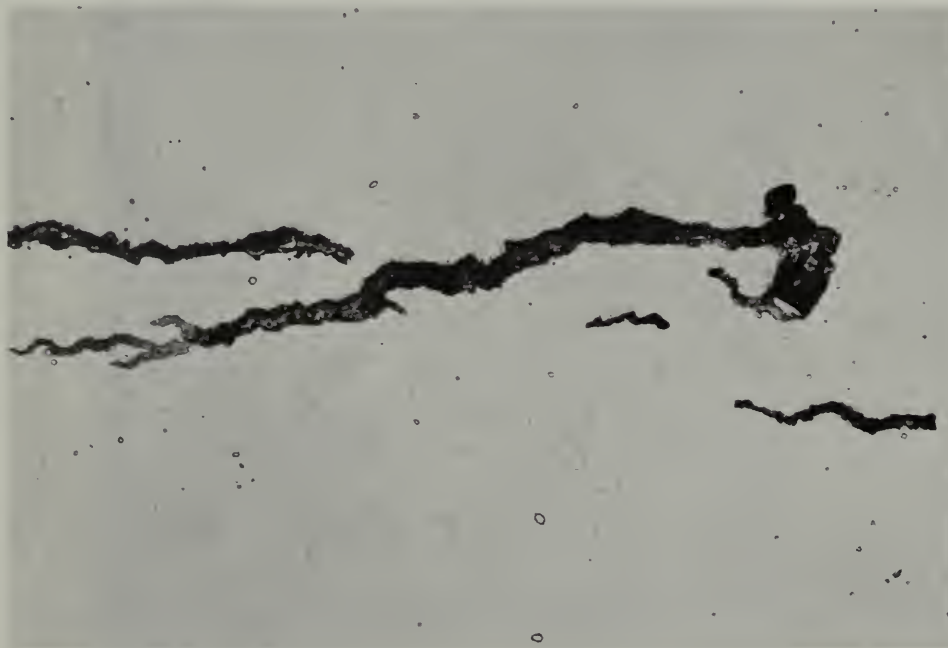
22. Typical crack appearance, 0.285 inch below south face. 200 X

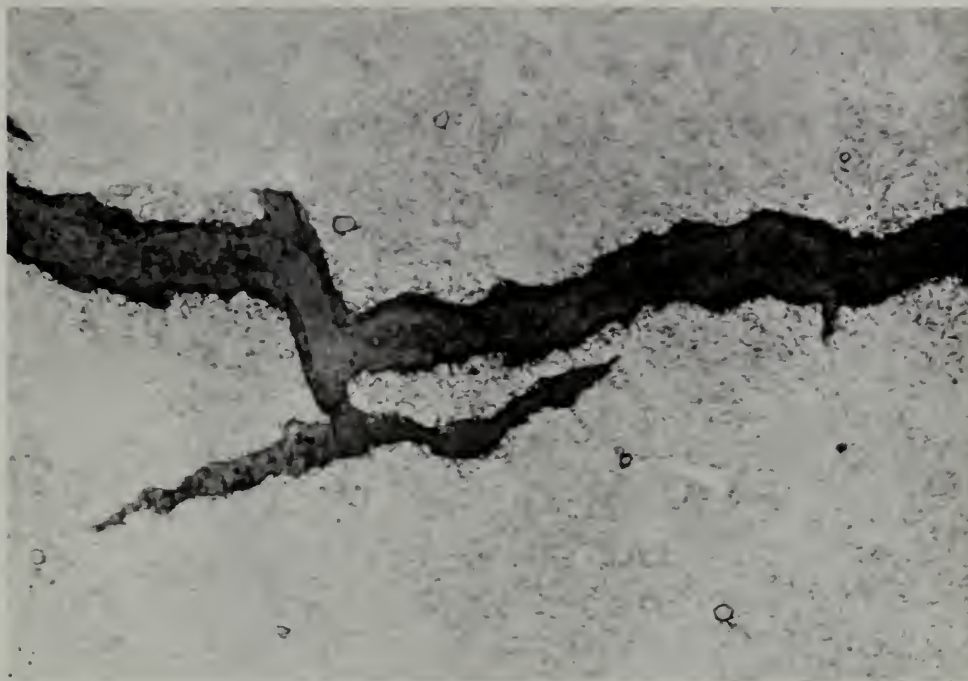
23. Lamellar nature of oxide in cracks, 0.285 inch below south face.  
1000 X

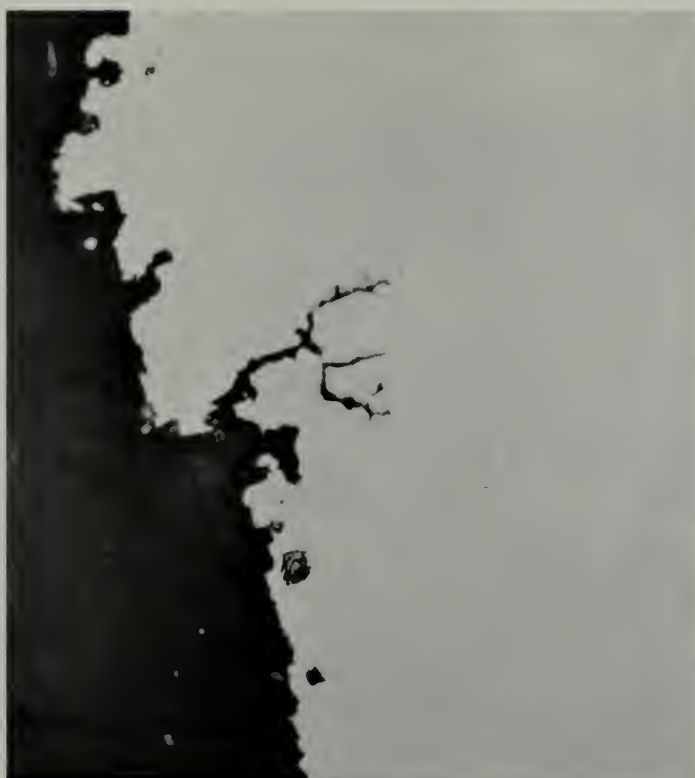
24. Incipient cracks at hole surface, 0.394 inch below south face.  
1000 X

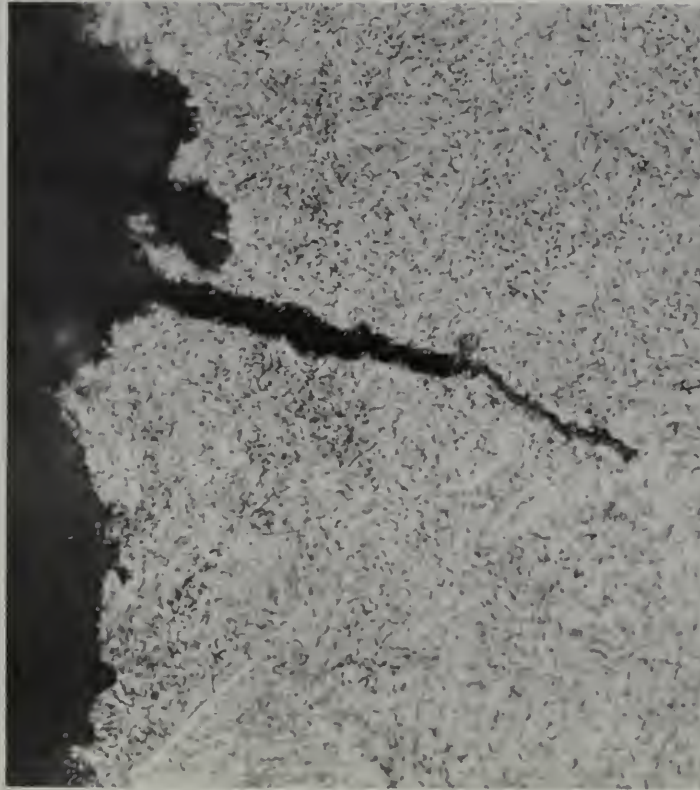
25. Crack propagating from hole surface, 0.394 inch below south face. Etched, picral. 1000 X

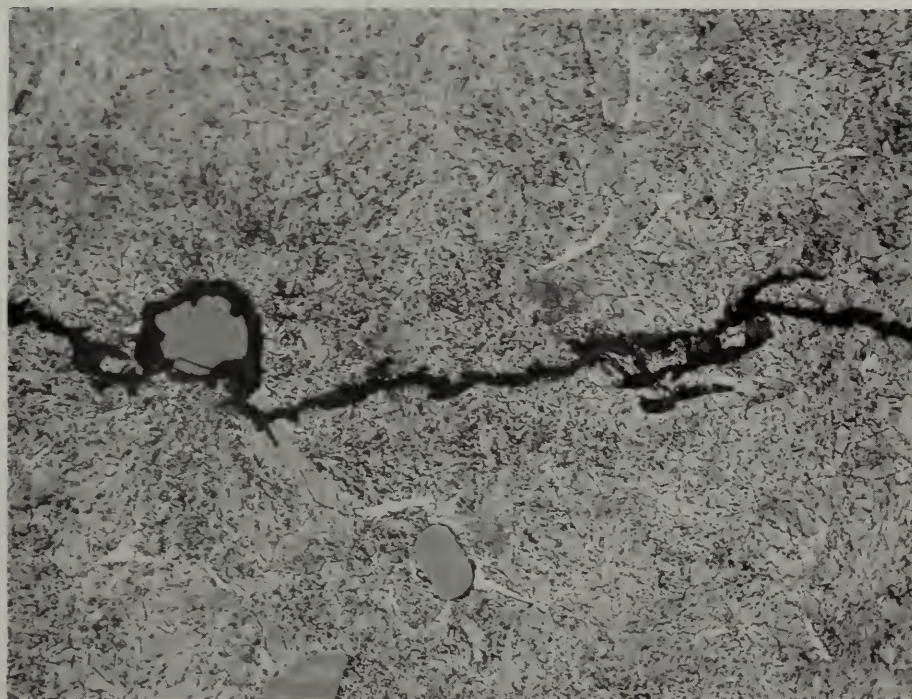
26. Typical crack appearance, 0.394 inch below south face. Etched, picral. 500 X

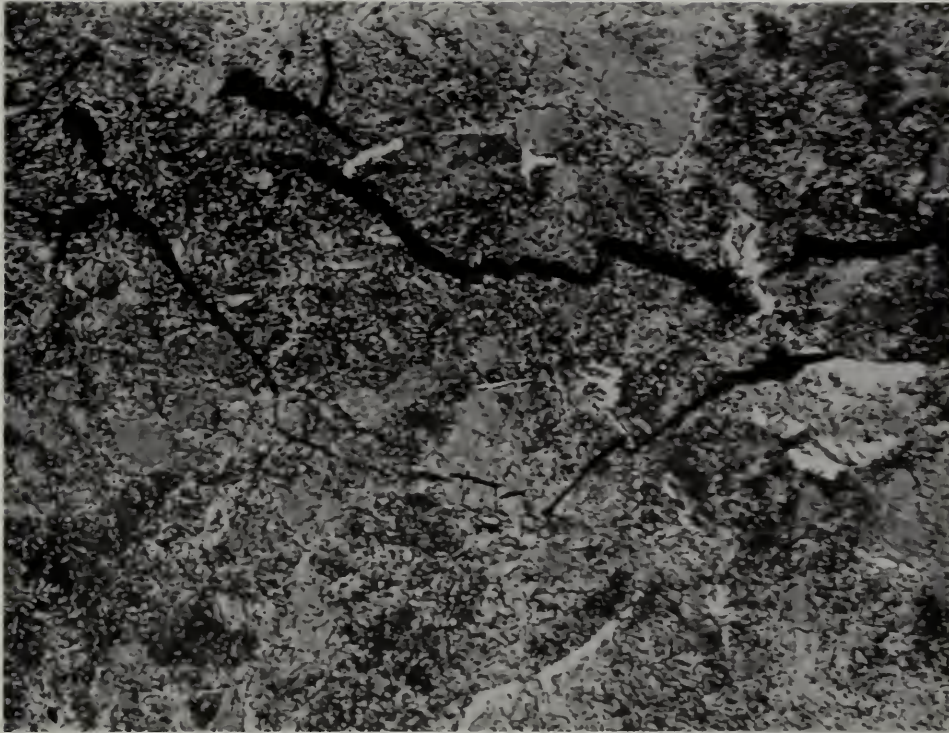
Secondary cracks close to a fracture are generally believed to indicate that the fracture was propagating at high speed. If this is correct, then our observations of secondary cracks indicate that fast fracture initiated in the lower side of the eye when the crack depth was only about 0.6 inch. Planned measurements of fracture toughness of the eyebar steel should make it possible to estimate if this is a reasonable value of critical crack length under the loading conditions at the time of fracture.

27. Secondary cracks adjacent to fracture, approximately 1/16 inch from hole surface. Specimen B, 0.6 inch below south face. Etched, picral. 800 X

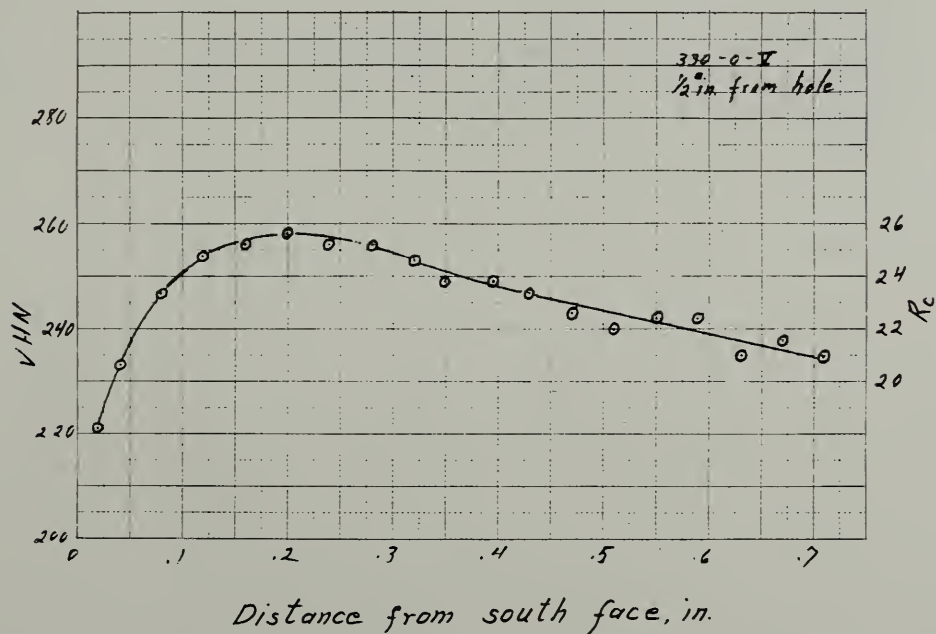
The change in structure is reflected in the change in hardness shown on figure 28: these values were obtained with a Vickers hardness tester (10 kg load) on specimen V and are therefore representative of material approximately 0.6 inch from the hole. Several series of hardness tests were made on longitudinal sections of specimens A and B, and no significant variation was found as a function of distance from the hole.

It may be significant that all of the cracks originated in a band near the position of maximum hardness, i.e. 0.1 to 0.5 inches from the south face. We understand that the local stress at the origin of the fracture may have been sufficiently high to cause plastic deformation of some metal at the surface of the hole; if this were the case, the hardest zone, having the highest yield strength, would have the highest local stress.

28. Variation of hardness with distance from the face of the eyebar. Measurements were made on a transverse section of segment "10" approximately 0.6 inch from the hole.

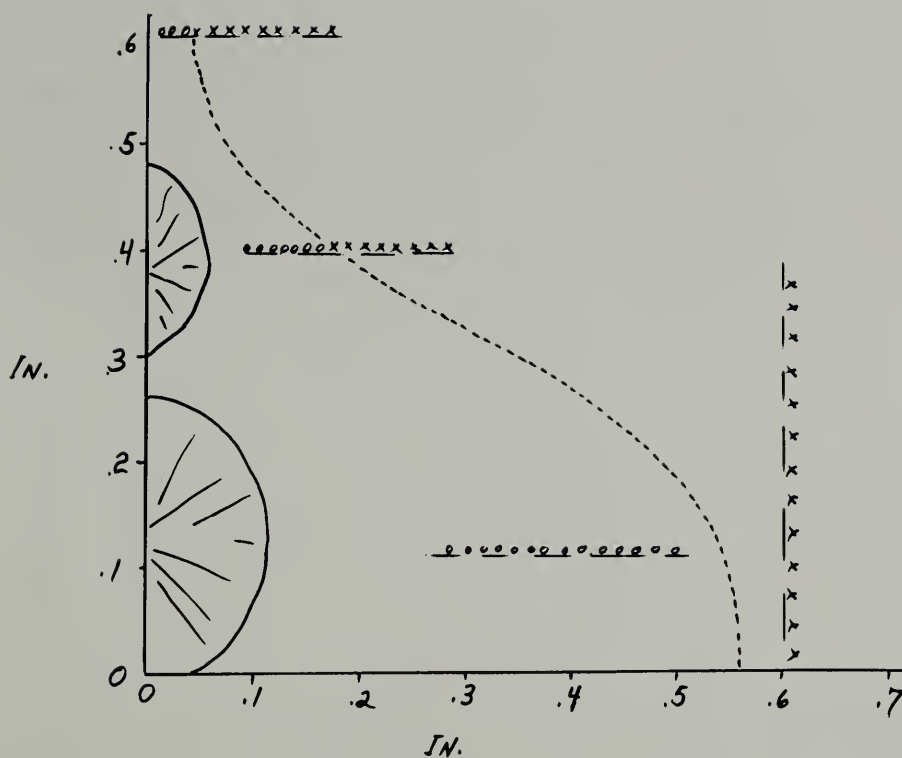
29. Sketch of the area near the origin on the fracture surface; hole surface is at left, south face at bottom. Dashed lines represent location of metallographic sections examined. ooo - no secondary cracks found; xxx - secondary cracks observed.
